DOT HS-801-969

# CRASHWORTHINESS OF THE SUBCOMPACT VEHICLE

August 1976

Final Report

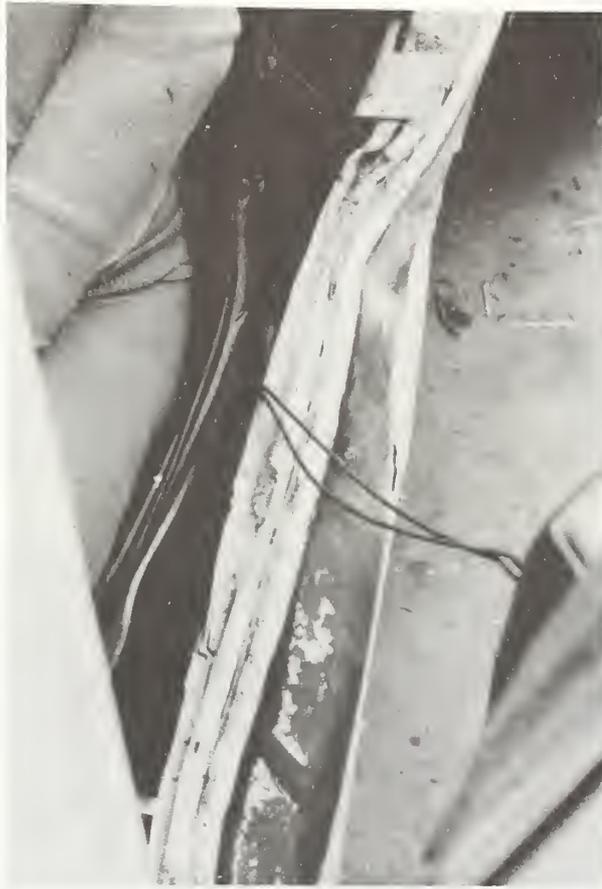
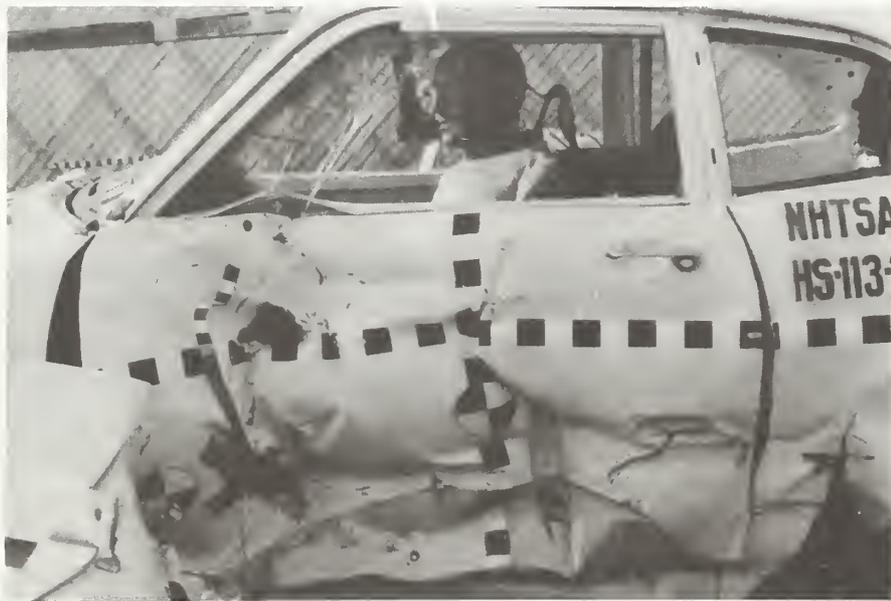
FIGURE 4.15 PHOTOGRAPHIC COVERAGE OF TEST E20

Pinto: The LTD struck the Pinto behind the A post. The door skin was crushed inwards but remained intact except where the LTD fender ornamentation perforated it. The door glazing cracked but remained in place. The rocker panel was crushed slightly, suggesting uniform lateral

A. Door Sill Area

B. Door of Target Vehicle

Both vehicles carried accelerometers, and full photographic coverage was provided. In addition, instrumented dummies occupied the driver's seat and left rear seat of the Pinto. Cameras mounted on the Pinto records dummy behavior. Data are summarized in Table 4.5. Photo coverage is represented in Figure 4.15. This test was reported on in the progress report dated May 1975 under this contract.

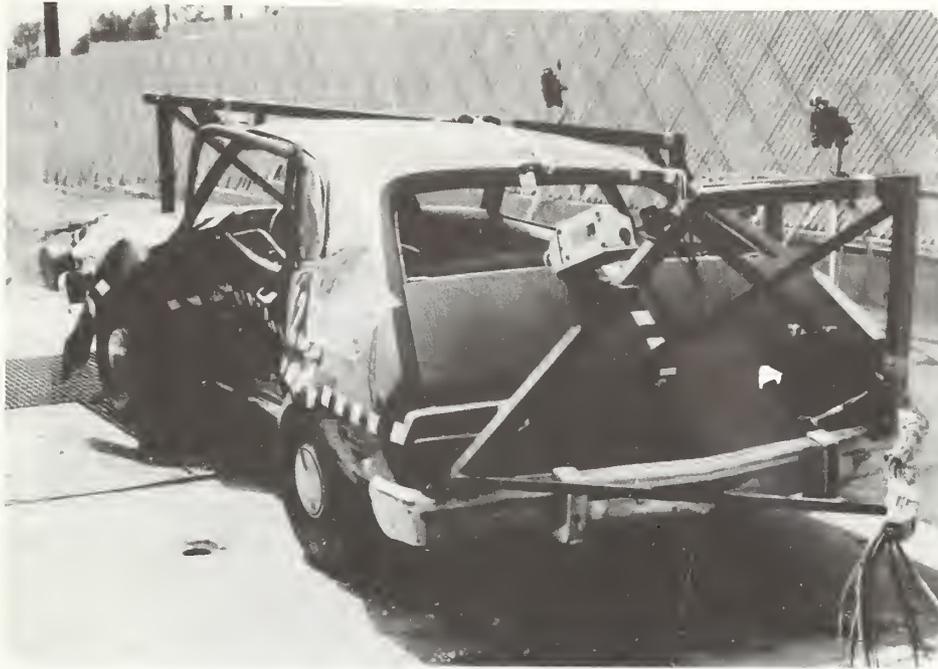
A. Left Rear Quarter

Bullet Vehicle: The modified car (E23) showed almost no damage except for incipient crush of the rightmost 12 inches of the hood and fender box where the crush was limited to a triangular volume about 3" deep at the rightmost corner of the hood.

Struck Car: The door intruded into the passenger volume, the intrusion being more severe in this than when the striking car was unmodified (E22). The floor pans showed an incipient buckle on the left tunnel.

Bullet Car: No compartment intrusion occurred in the modified car.

Data are summarized in Table 4.5. Photographic coverage is represented in Figure 4.16. This test was reported in the progress report dated August 1975 under this contract.

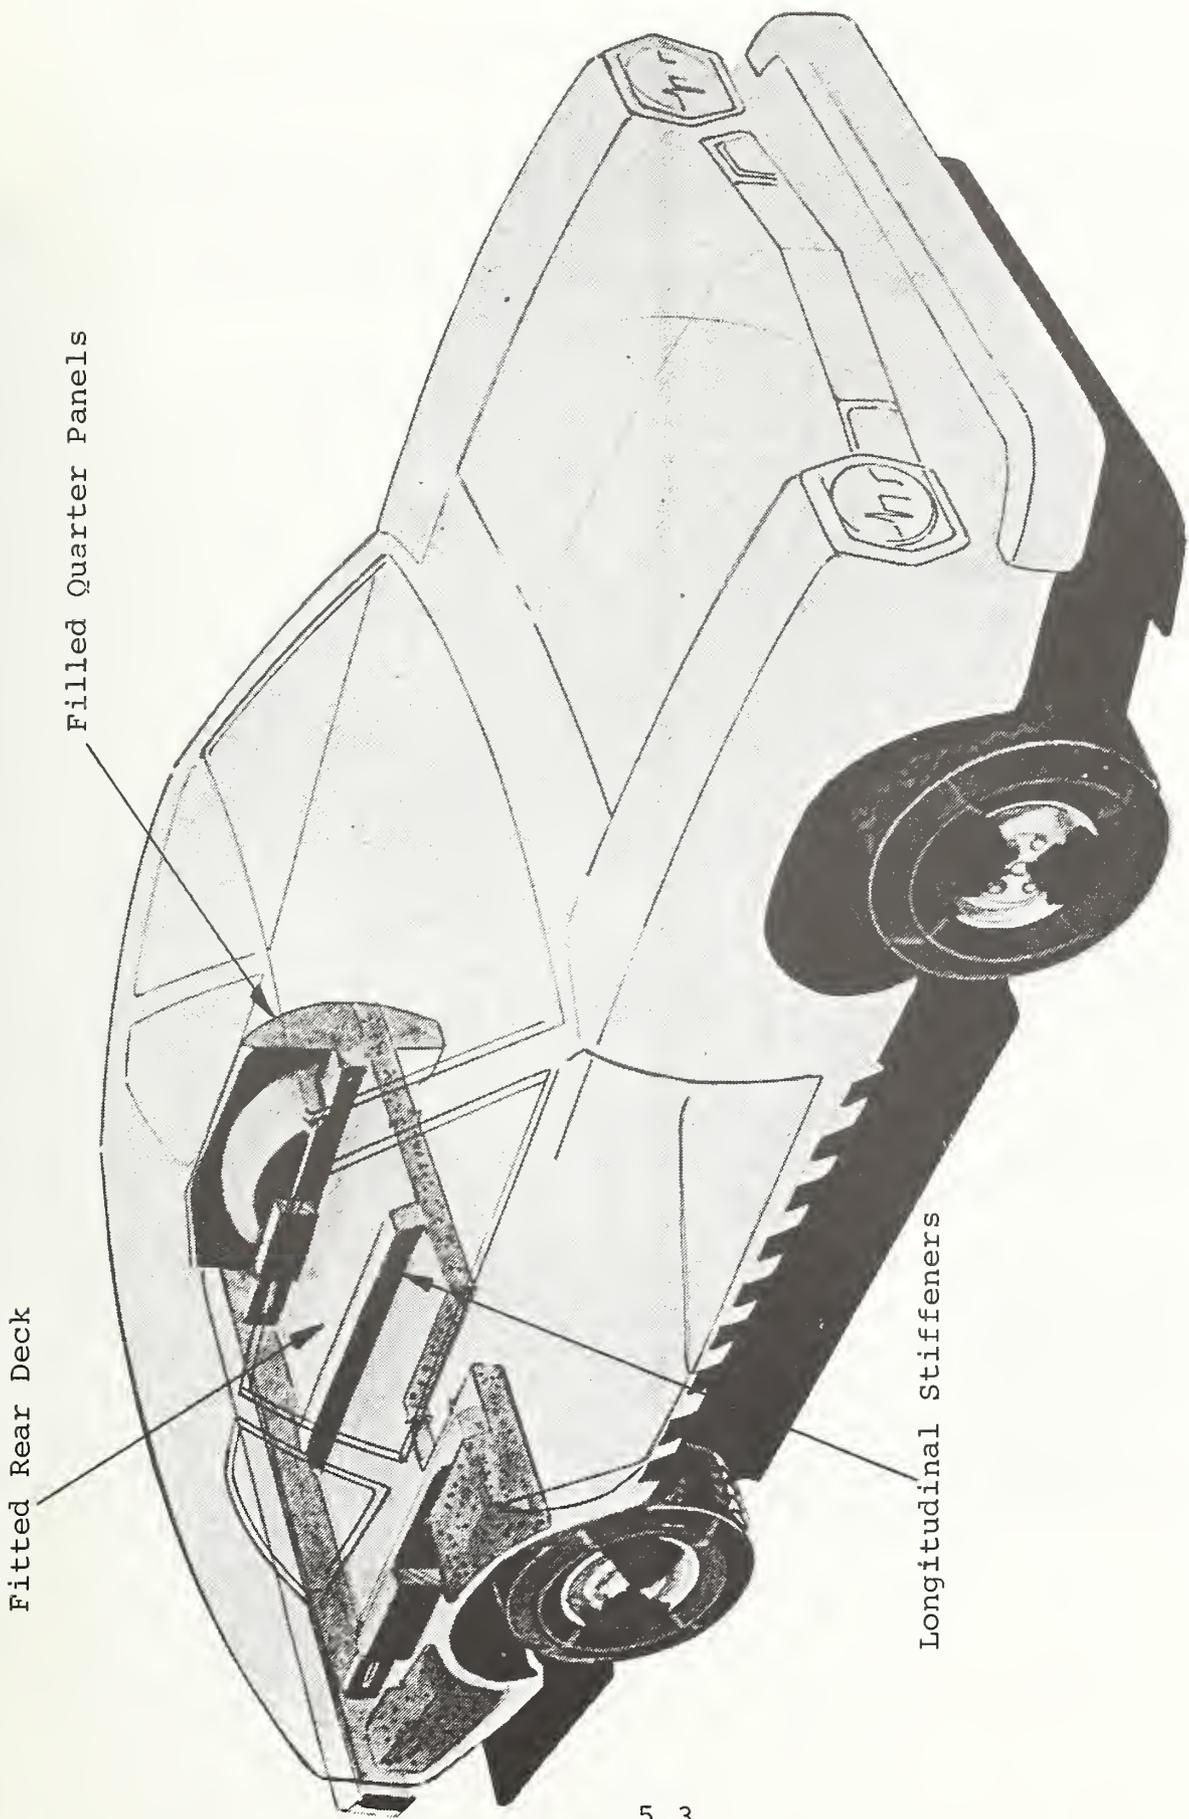
FIGURE 5.1 REAR MODIFICATIONS

1. Three longitudinal sheetmetal beams, 3" x 5", extend from the aft of the vehicle to the B post lateral beam. The two outside beams are just inboard of the rear wheel wells. The third beam is on the centerline of the vehicle. All were filled with 2 lb/ft<sup>3</sup> polyurethane foam.
2. The original rear deck is replaced with a 2" thick sheetmetal-foam sandwich panel.

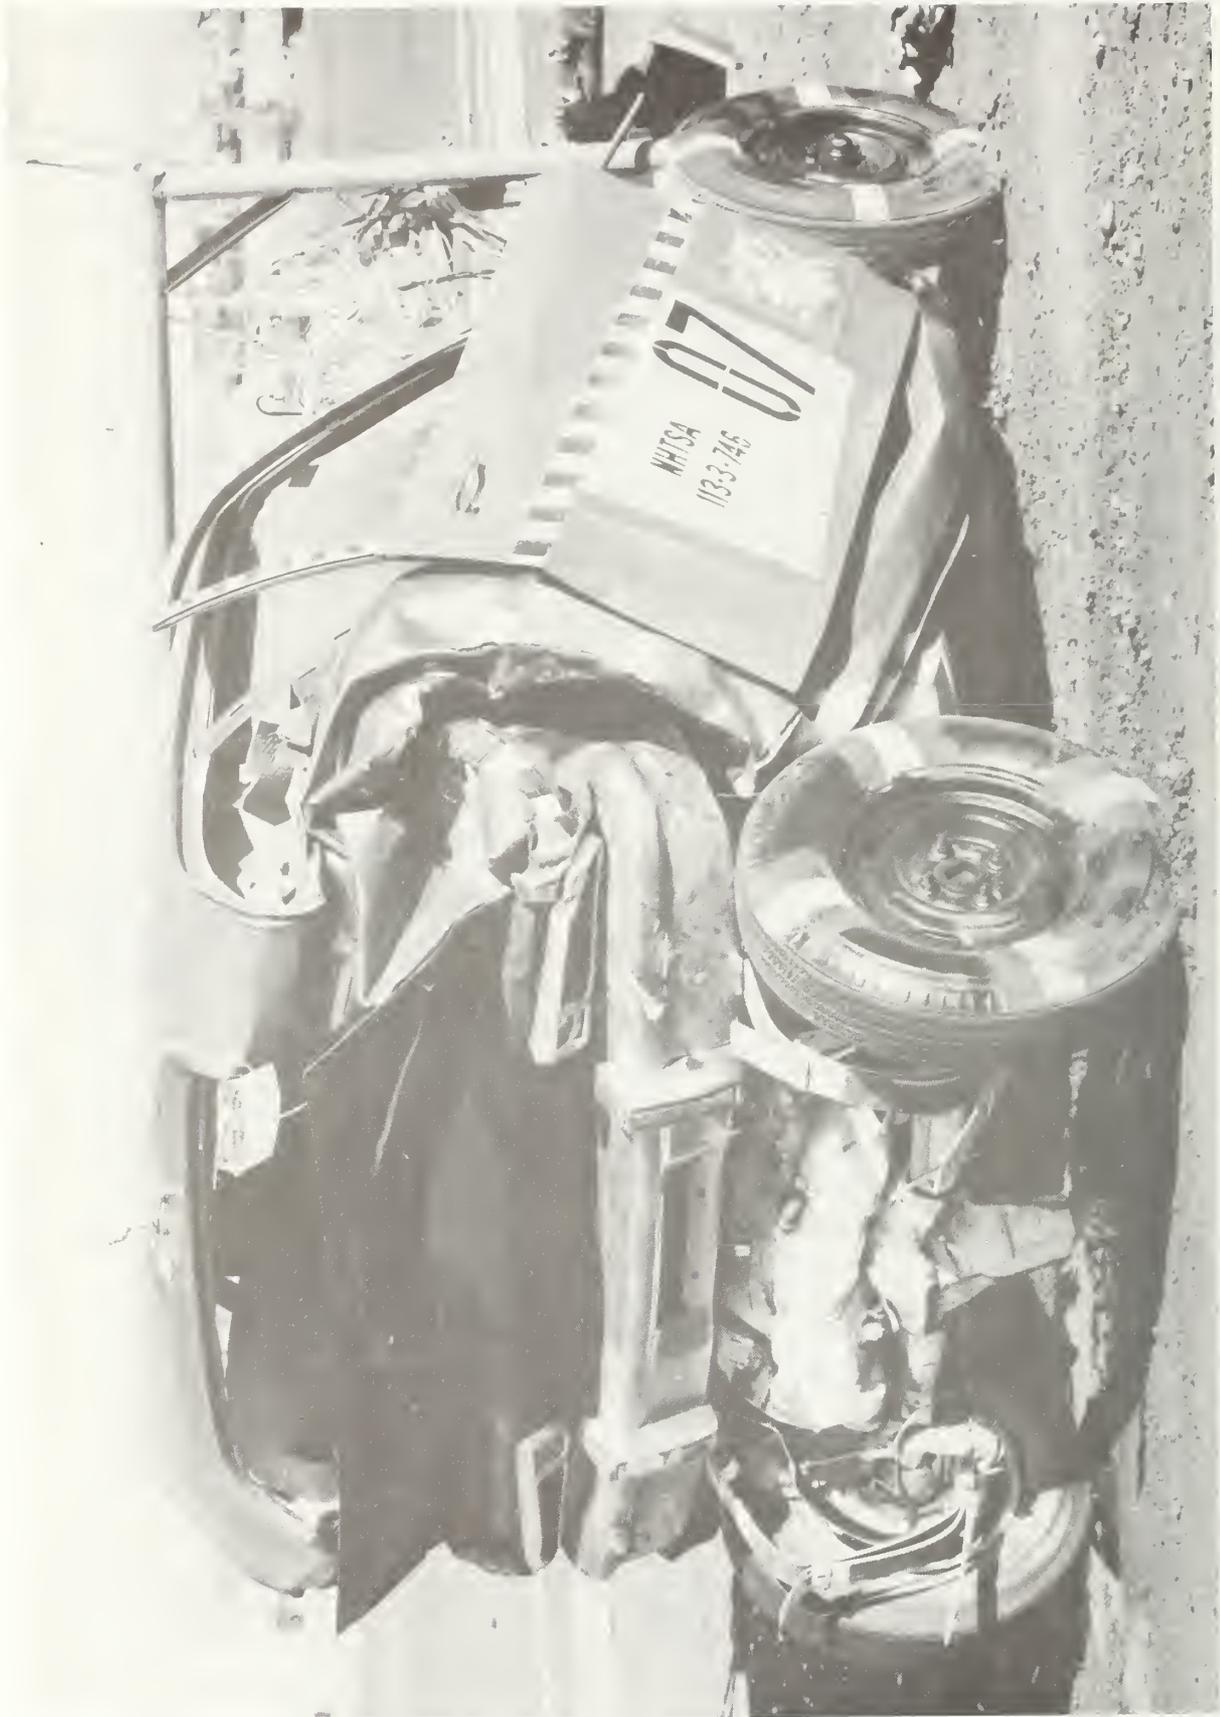
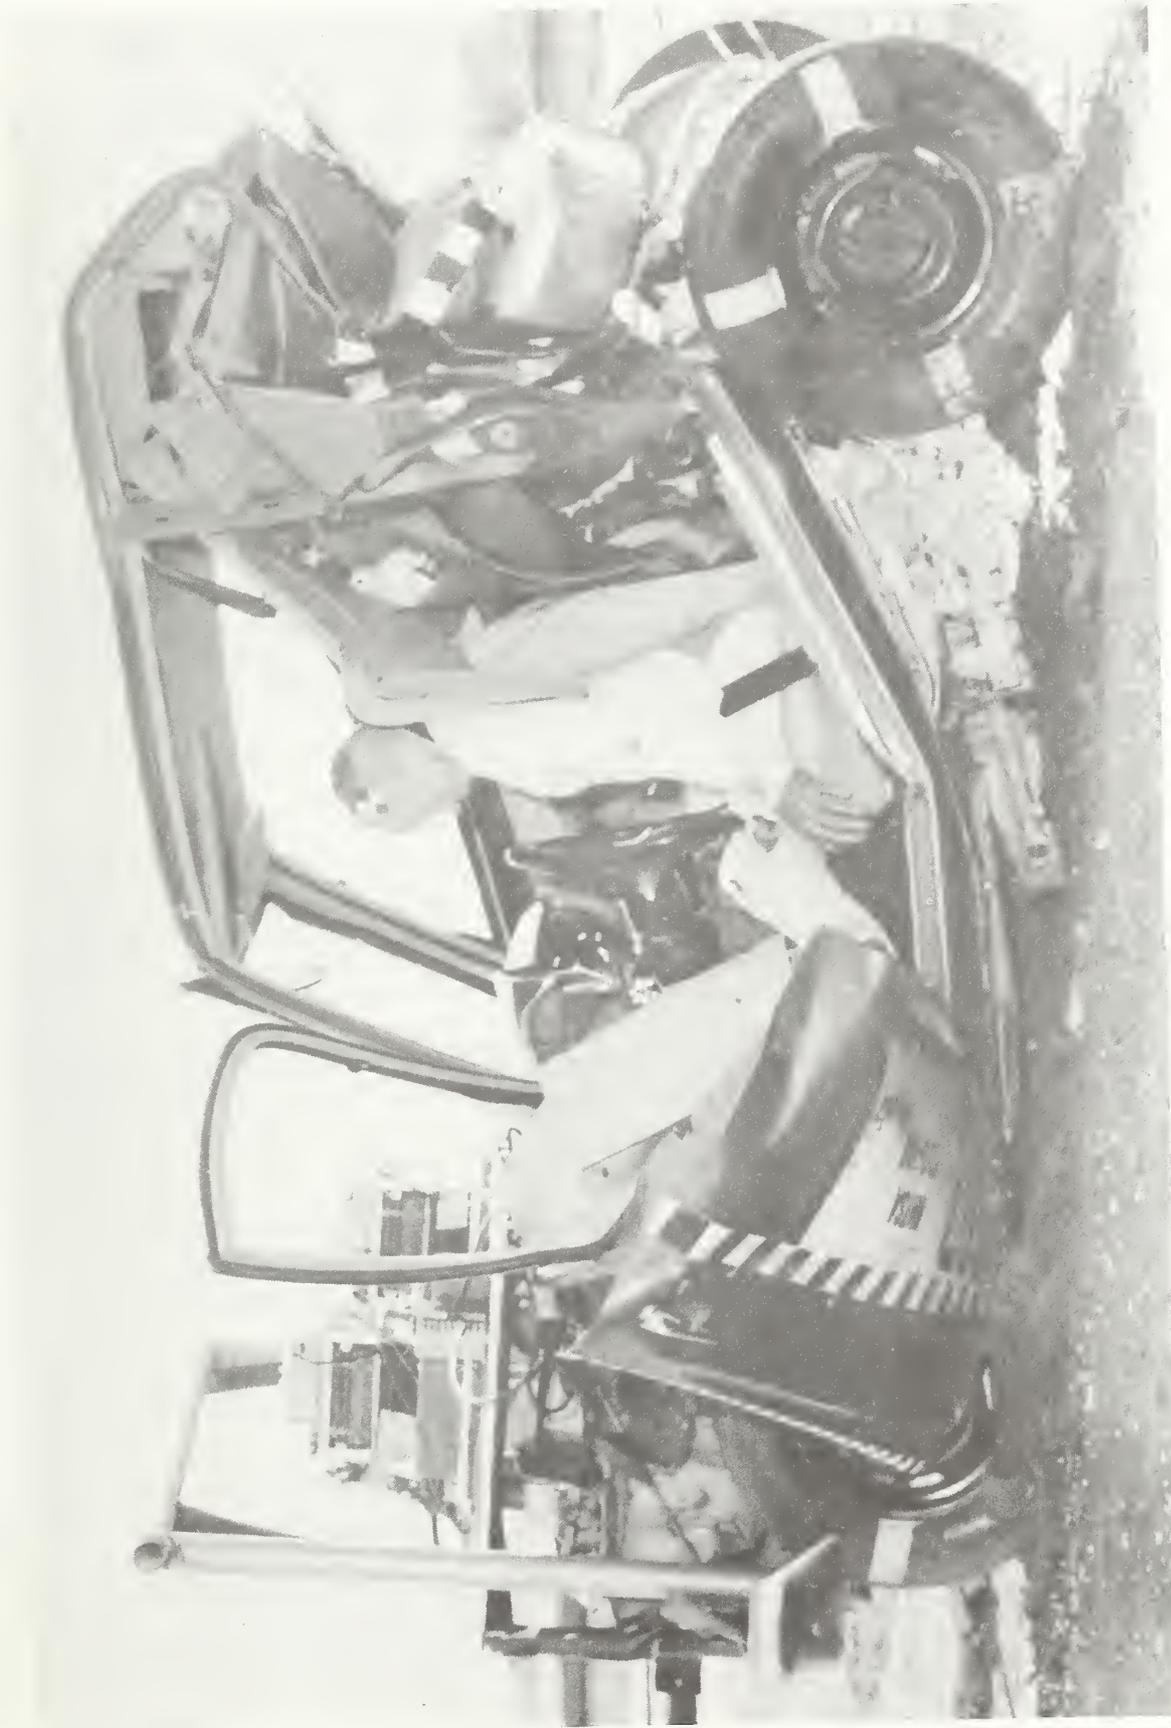
FIGURE 5.2 PHOTOGRAPHIC COVERAGE OF BASELINE TEST 07

<u>Test 07</u>
Test Date	1/15/74
Test Description	Large sedan front into stationary subcompact rear
Impact Velocity (mph)	60.2
Large Car	'68 Plymouth
Small Car	'74 Pinto (previously used in 30 mph frontal barrier impact)
Static Crush (in)	51.0
Peak Acceleration(g's)	21

A. Post-test Rear Quarter View of Pinto

B. Post-test Side View of Pinto

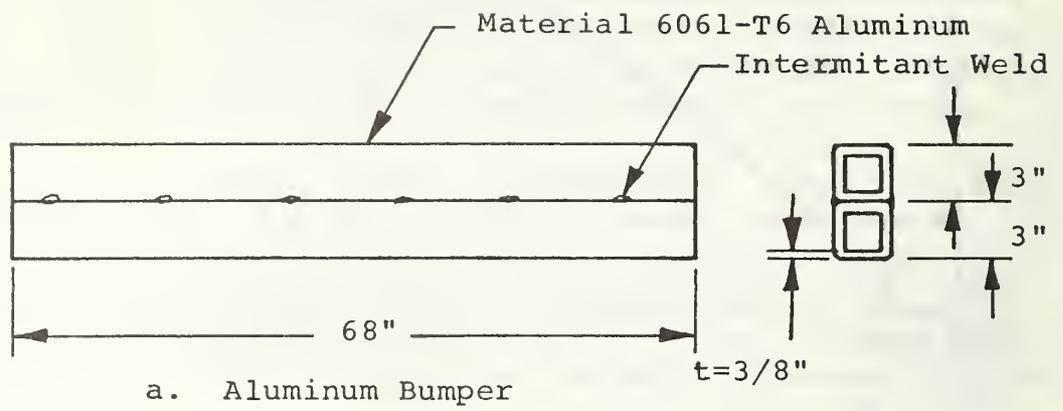
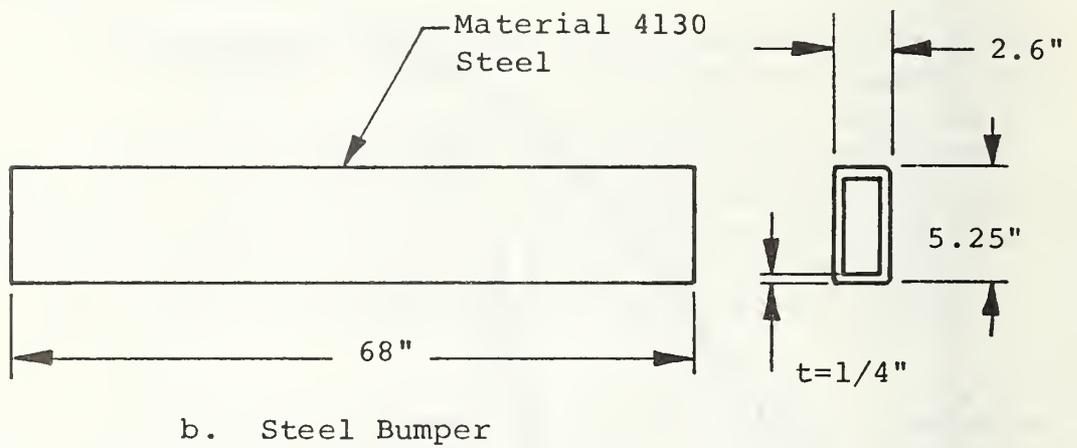
FIGURE 6.4 ALTERNATIVE BUMPER DESIGNS

Minicars selected the aluminum design because of its light weight of 30 pounds, as opposed to 43 pounds for the steel bumper. The failure mode for a bumper under pole impact is

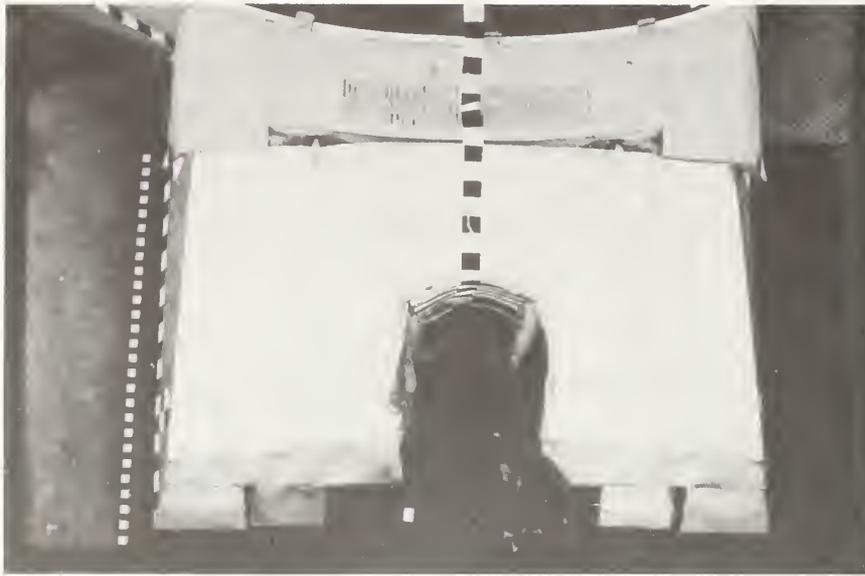
A. Top View With Hood In Place

Exterior Structural Damage: The rigid pole contacted the bumper about 1-1/2" left of center. The EA units stroked the full 6". The bumper bent under pole impact to approximately a 20° angle. The left lower frame formed 4 complete accordian folds and developed an S shaped failure, with the forward portion sliding inside the aft portion. The right lower frame started to form the S shape failure, with the forward portion outside the aft portion, and then bent upward at the S Section.

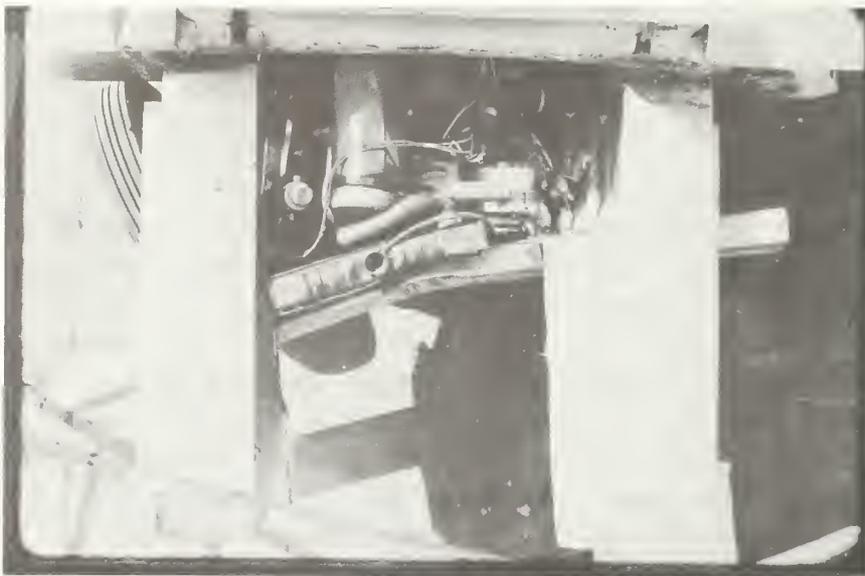
B. Top View of Engine Compartment

FIGURE 6.5 PHOTOGRAPHIC COVERAGE OF TEST E2

Test E2 was a 40-mph frontal pole impact test of the modified subcompact vehicle. The test was conducted at a lower velocity than the design goal, at the discretion of the CTM. It was felt that more valuable information could be obtained at this impact level. The test article was instrumented with the standard seven triaxial accelerometers. Photographic coverage included four high-speed cameras, a real-time camera, and 35mm still photographs both pre and post test. Physical measurements of the vehicle were taken both before and after the test to determine the crush distances. The photographic data is summarized in Figure 6.5 and the physical data is presented in Table 6.1. The complete test report is presented as an attachment to the October 1974 progress report.
